BS EN 13823:2020

Reaction to Fire Tests for Building Products - Building Products Excluding Floorings Exposed to the Thermal Attack by a Single Burning Item

A Report To: Wallbarn Ltd

Document Reference: 505205

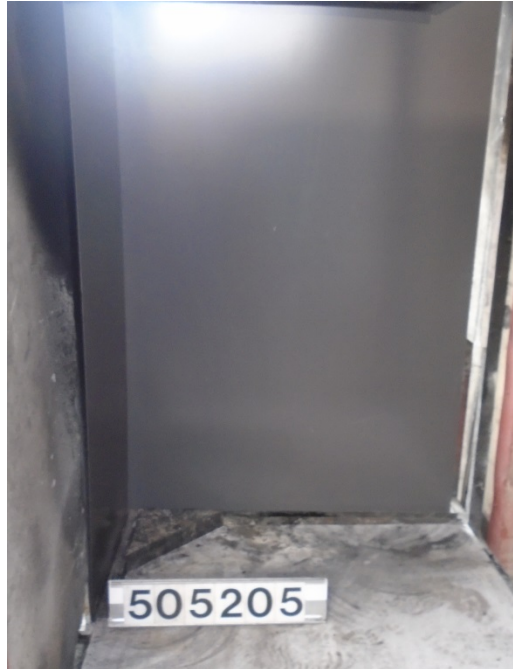
Plate 1: Total View of the exposed surface of the long wing.

Photographs of the installed product are appended as Plates 1 and 2 in Appendix 1 of this report.

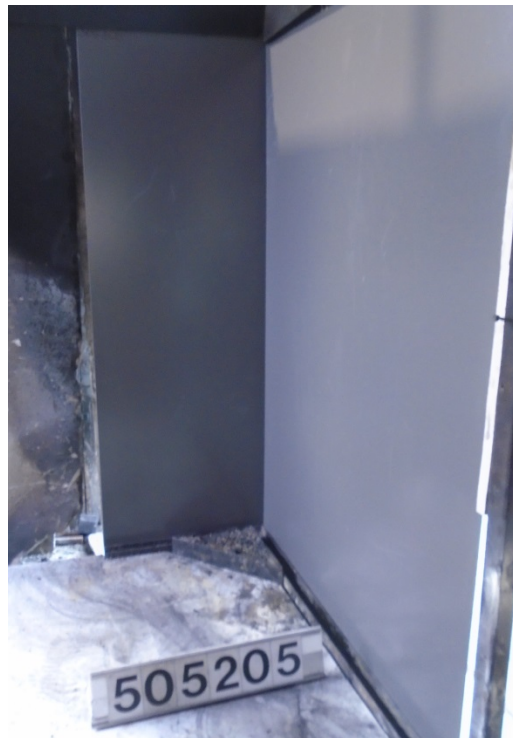
Plate 2: Close up view of the vertical outer edge of the long wing at a height of 500mm
