Indicative test Report No. 20873B-rev.1

M-Tray® modular green roof system

Test methods for external fire exposure to roofs: Test 4: Method with two stages incorporating burning brands, wind and supplementary radiant heat, according to CEN/TS 1187:2012: Test 4.

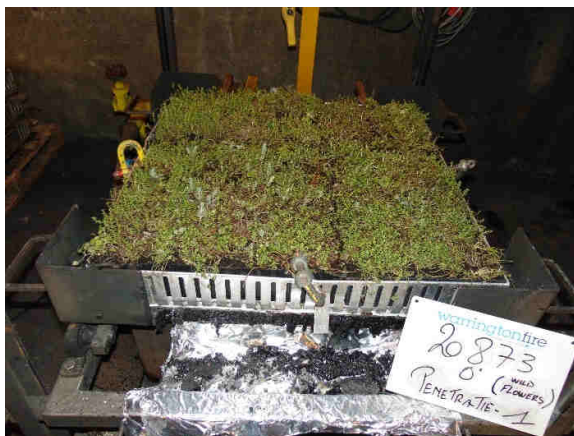
Penetration B-1: Before

Specimen No:	B-1(*)	B-2	Average
Time to fire penetration (min:sec)	Did not penetrate	Did not penetrate	Did not penetrate
Nature of the penetration	N.a.	N.a.	-
Additional observations: None of the specimens ignited.
